Title: Product information - Intergas Viton front seal replacement program

Date issued: 14 Feb 2022

Introduction

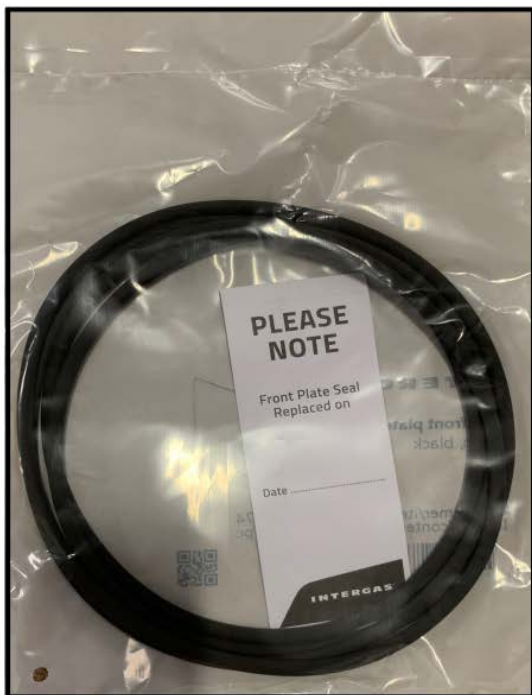
Black Viton front plate seal with seal replaced sticker

If you have been servicing Intergas boilers and have not been using the new black Viton seals, then these are available from your normal stockist. Please dispose of any red Silicon seals or send them back to Intergas Heating Kidderminster and they will replace them with the new black Viton type FOC.

- 086474 Large Viton black seal (Replaces 876597 red Silicon seal)
- 086504 Medium Viton black seal (Replaces 877927 red Silicon seal)
- 086514 Small Viton black seal (Replaces 876467 red Silicon seal)

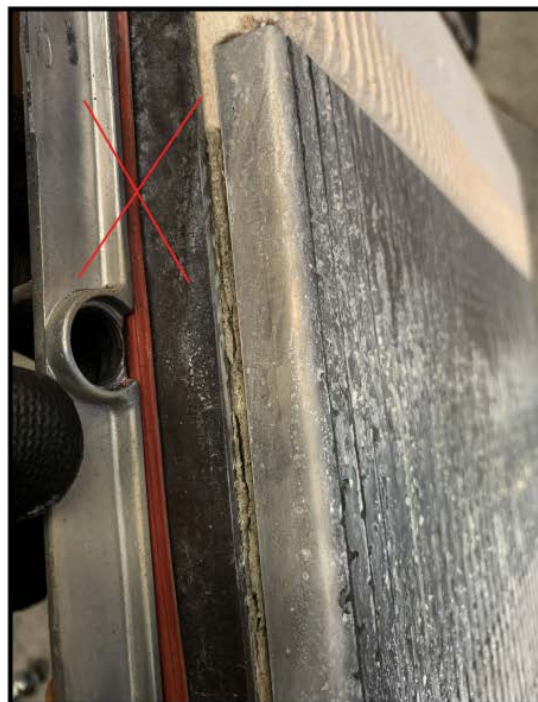
Back in 2017, Intergas Heating identified an issue with the red silicon front plate seal fitted to their boilers. This seal was upgraded to help improve the longevity of the seal.

Since 2017, Intergas Heating has been monitoring their existing range that remained with the red silicon front plate seal, and the results showed that seal failure occurred on a small number of boilers that had not been serviced correctly on an annual basis, or where they had undergone persistent fault code resets by the end user. Safety Alert 029 was produced to highlight this issue.

Old type Silicon red seal (do not use)

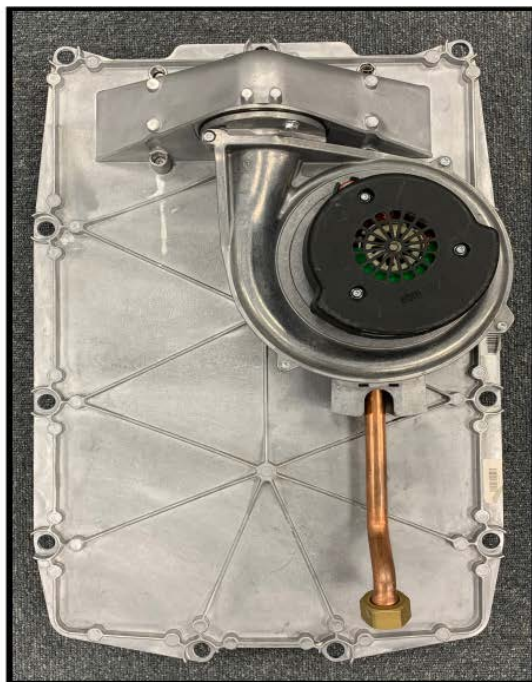
A typical front plate with fan assembly attached

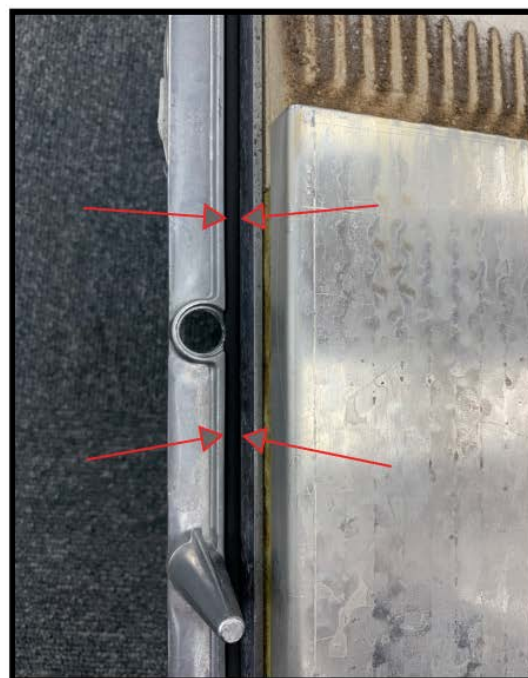
Rear of Front Plate showing Black Viton seal correctly located within the recess.
